**YOUR WORKPLACE FIRE PRECAUTIONS LEGISLATION
PERIODIC REVIEW OF FIRE RISK ASSESSMENT HAS BEEN PREPARED BY**

ELITE FIRE LTD, UNIT 17 NORTHBROOK BUSINESS PARK, WORTHING, WEST SUSSEX, BN14 8PQ, 01903240469

**FOR
ST. CHRISTOPHER'S SCHOOL**

Address of Property:	33 New Church Road, Hove, East Sussex, BN3 4AD.
Person(s) Consulted:	Mary Campbell
Assessor:	Martin Turner
Date of Fire Risk Assessment Review:	18/03/2016
Date of Previous Fire Risk Assessment Review:	March 2015
Suggested Date for Next Review:	March 2017

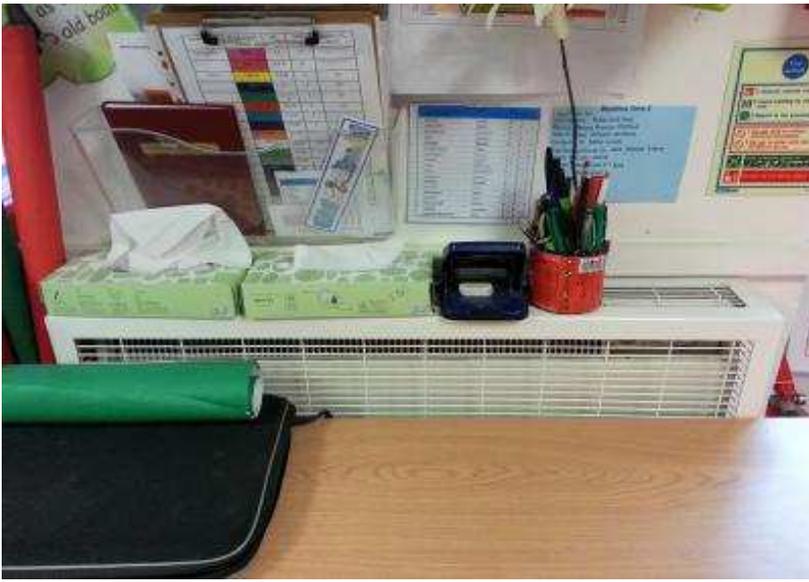
Img 3.2A

PAT testing is completed in house and under a rolling schedule. The fixed electrical test was last completed in July 2011 and is scheduled for re-testing this summer. A no smoking policy is in place. Teachers will supervise children in lessons using heat-generating apparatus. The kitchen extract system is subject to regular deep cleaning. There was a loose electrical wall socket in 8H. Combustible material was stored on the heater guard in 2P - see picture 3.2A. See remedial action plan.

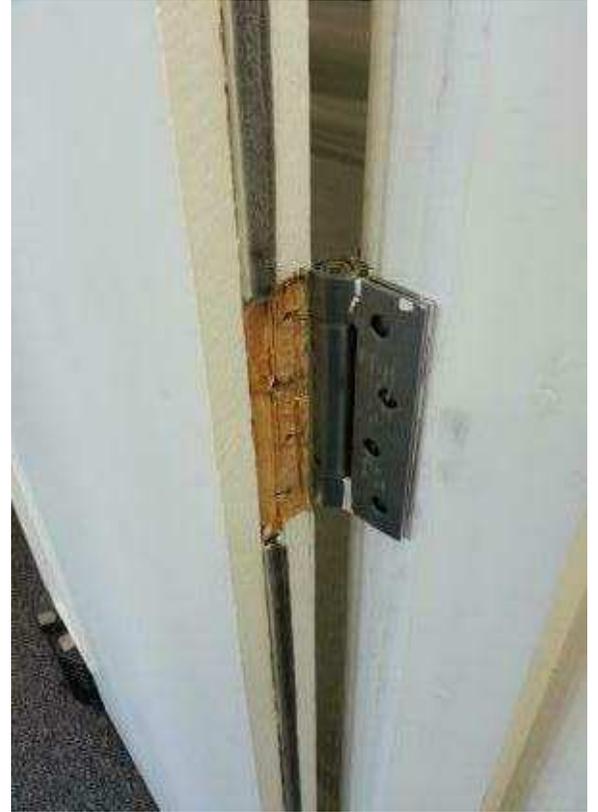
Img 7.2A

From a visual inspection of accessible areas, compartmentation seems sufficient. Due to the age of the building there may be areas that aren't, but additional precautions such as fire doors and a suitable fire alarm system are in place. The 2nd floor practice room has a hinge detached from the fire door - see 7.2A. The fire door to classroom 3 has a cracked lower panel - see picture 7.2B. See remedial action plan.

3.2	Remove the combustible material from the electrical installation in the computer block.	2			
7.2	Re-fit the fire door hinge.	1			
7.2	Repair or replace the lower panel on the fire door to remain an effective barrier.	2

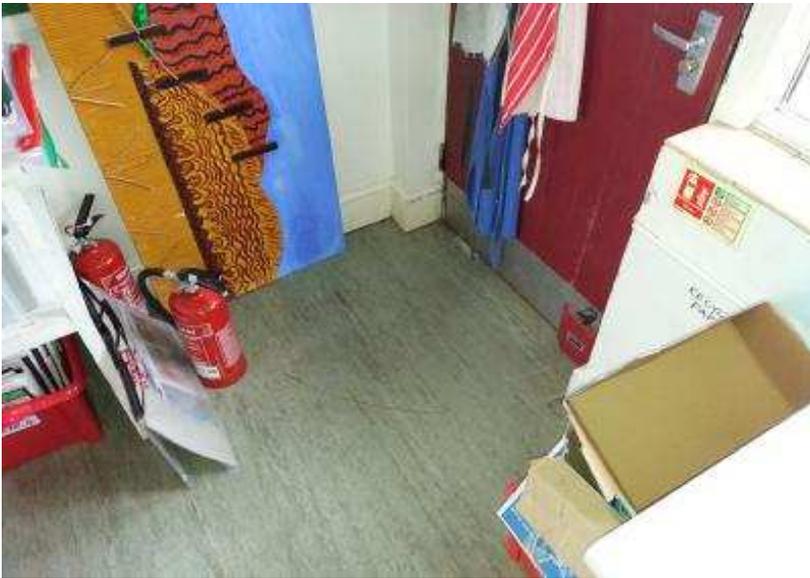
Img 11.2A

Fire extinguisher points were generally kept clear and accessible. Additional electrical cover for the hall is recommended (nearest one is in the kitchen). There were two water extinguishers in classroom 16, where only one should be - see picture 11.2A. See remedial action plan.

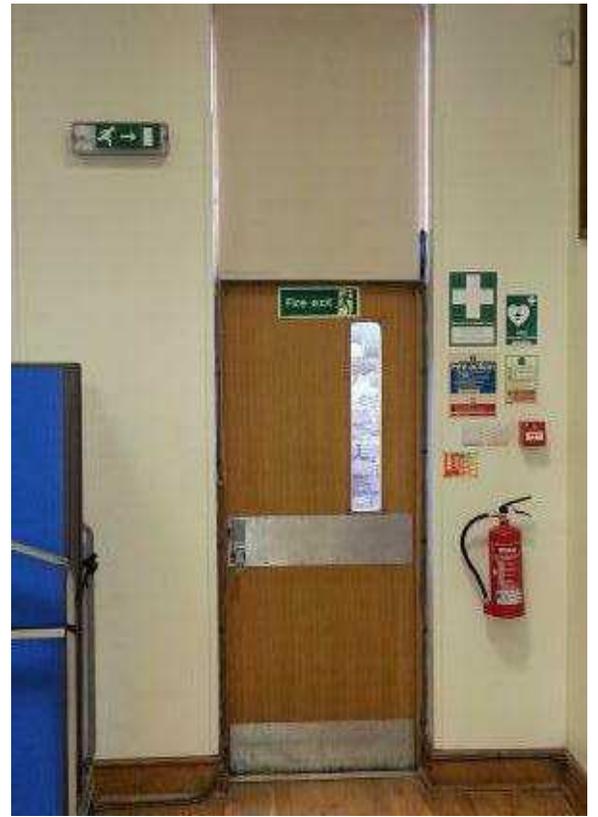
Img 9.2A

Suitable levels of fire safety signage were on display. Each classroom has a copy of the fire evacuation procedures fitted and visible. The legend on the emergency light in the dining room should be removed as there is already a specific sign here, it blocks the light given off and the legend does not comply with current standards - see picture 9.2A. See remedial action plan.

9.2	Fit identification signs to all mcp's.	1			
9.2	Remove the legend from the dining room emergency light.	2			
9.2	Re-fit the outside fire exit keep clear sign.	1
